# ESR n°9:

## Investigation on PV Module degradation mode indicators

NATIONAL RENEWABLE ENERGY CENTER (CENER)

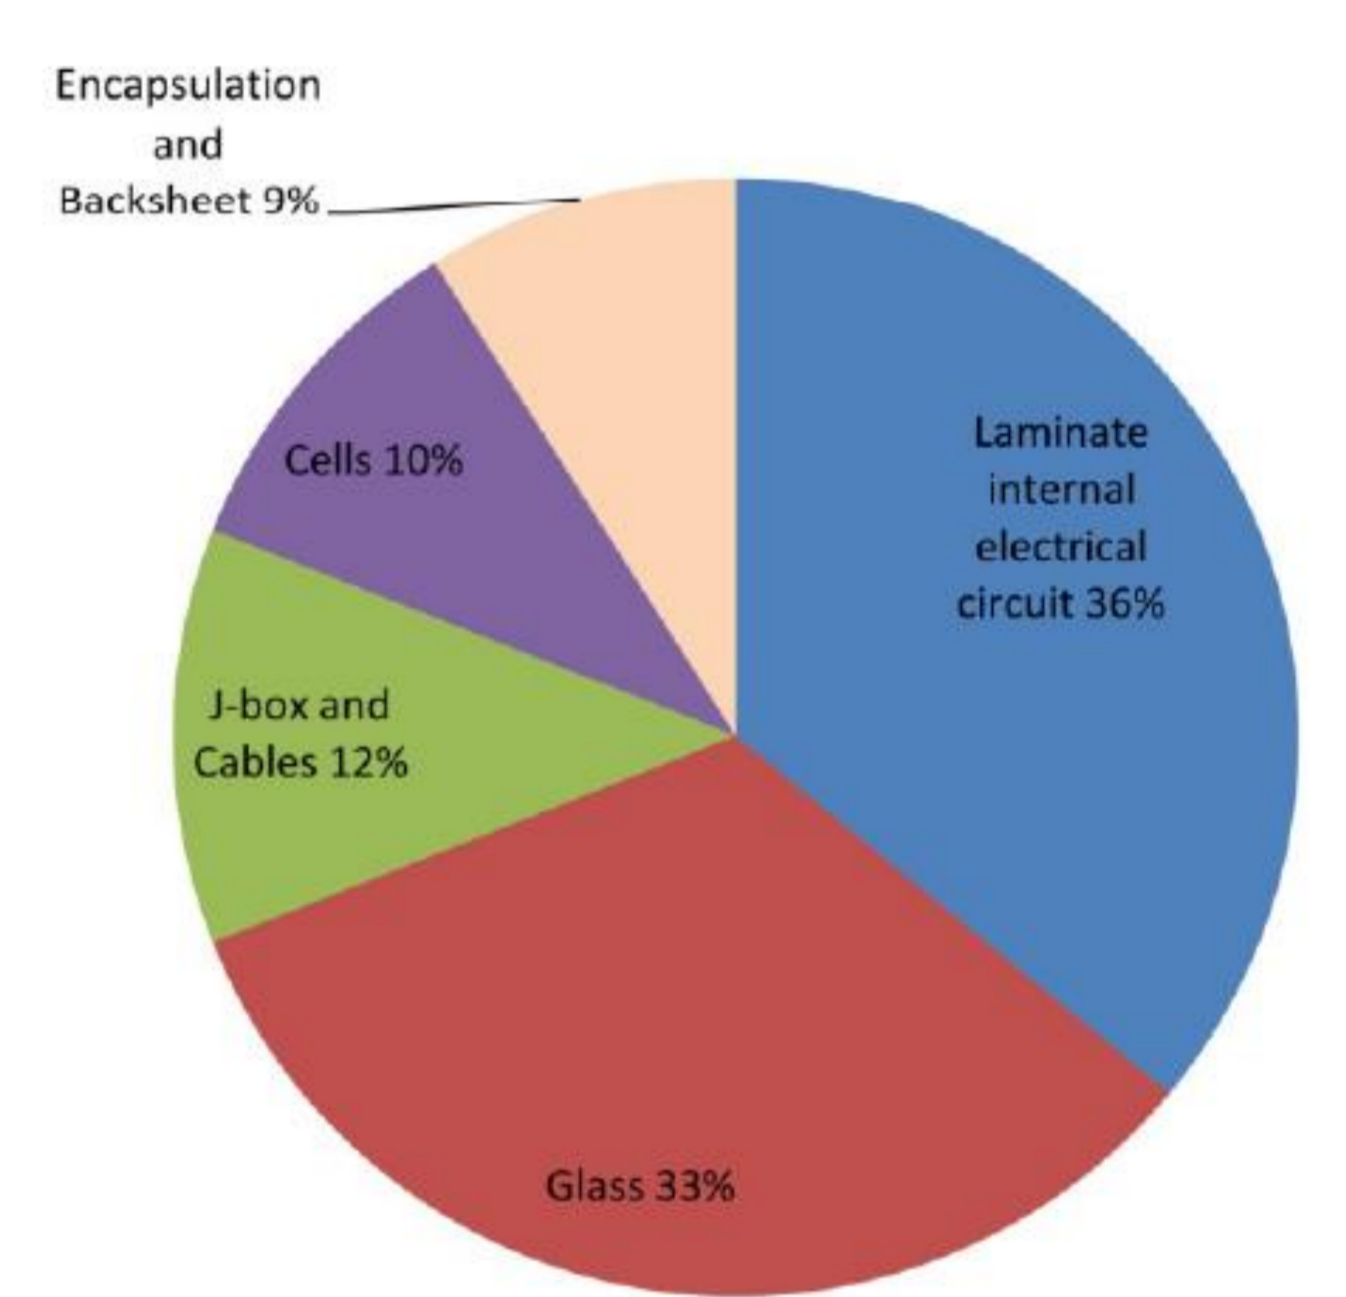
Failures distribution after 8 years

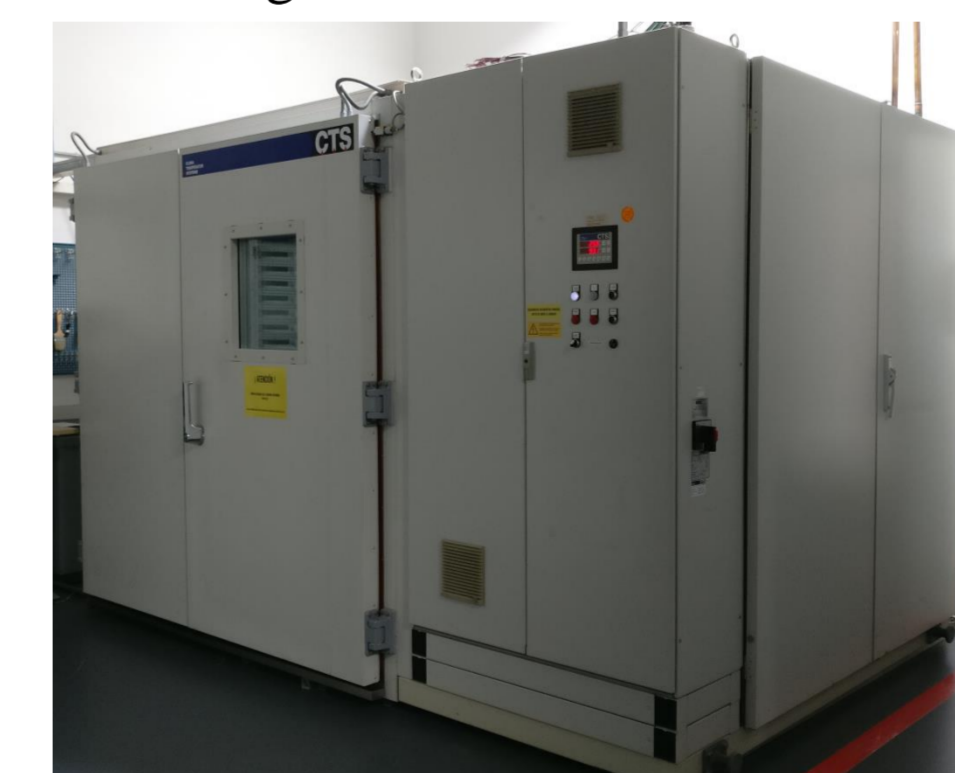
Multi-Usage climatic chamber at CENER

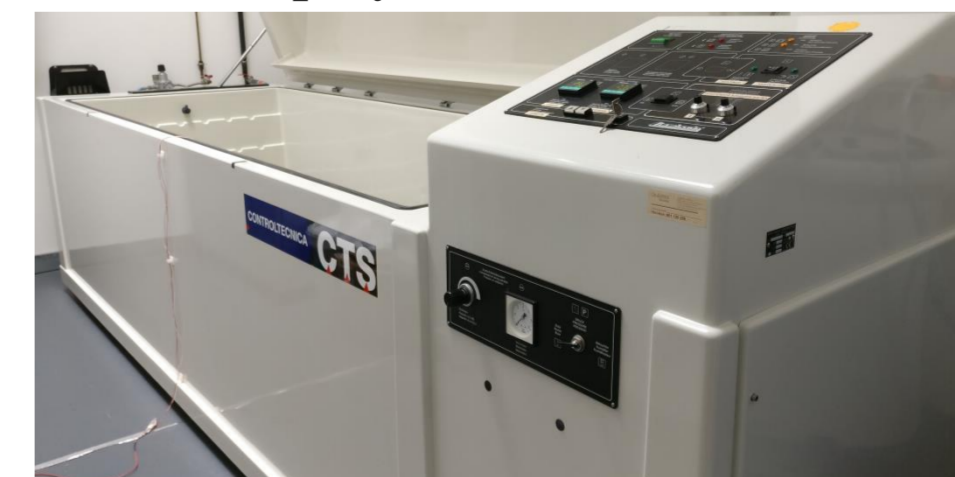
Salt spray chamber at CENER

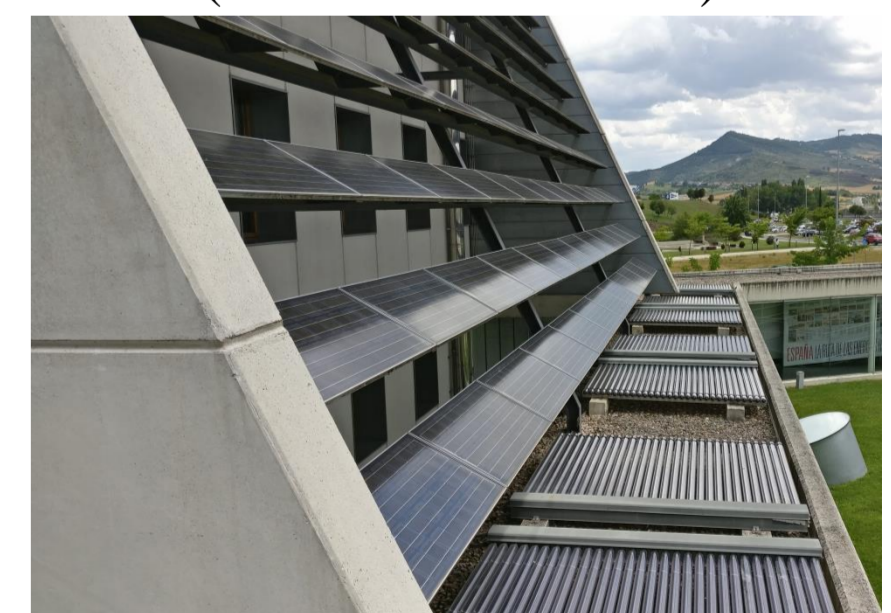
Built-in PV panels at CENER, (Installation in 2005)

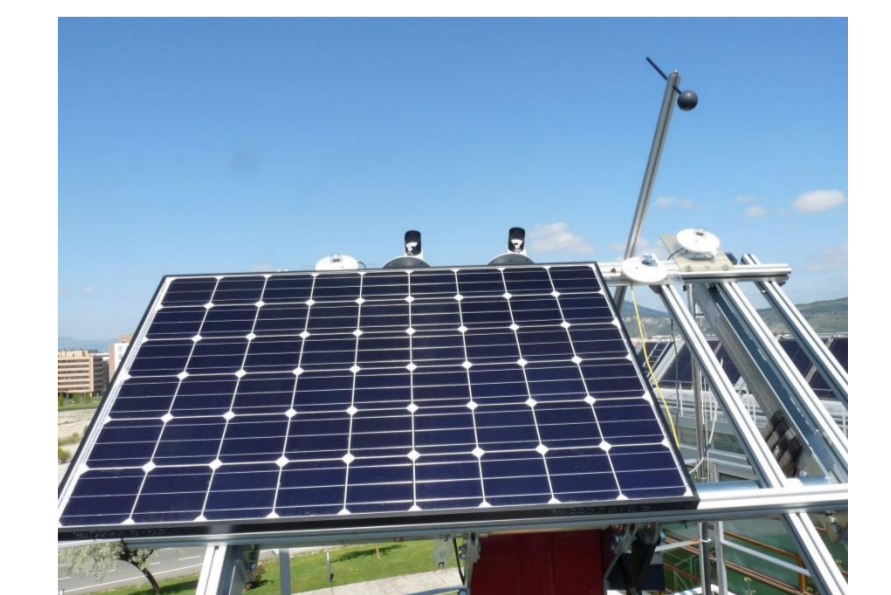
Two-axes trackers on the roof
